ROOT CAUSE ANALYSIS REPORT

Downtown Underground Network Event on August 13, 2014

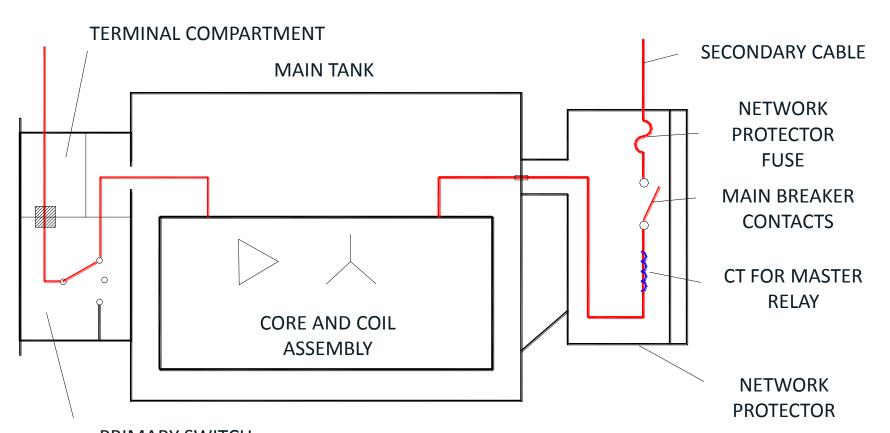
IPL'S ROOT CAUSE ANALYSIS IDENTIFIED THE TWO POSSIBLE EVENT SCENARIOS

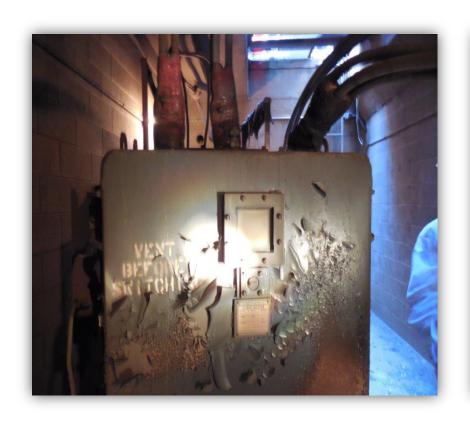
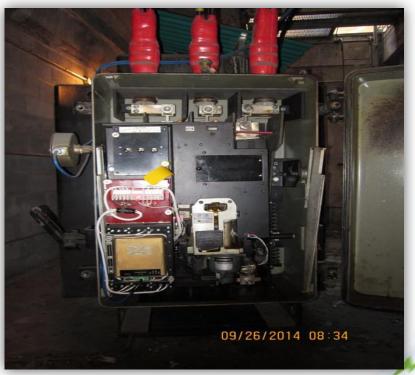
THE EVENT WAS COMPLETELY CONTAINED IN THE NETWORK PROTECTOR

The Network Protector door remained closed which reduced damage to other vault equipment
